# Man Overboard - Fatal Morgan of Marietta

2022 Newport  
Bermuda Race  
Based on the US  
Sailing Inquiry

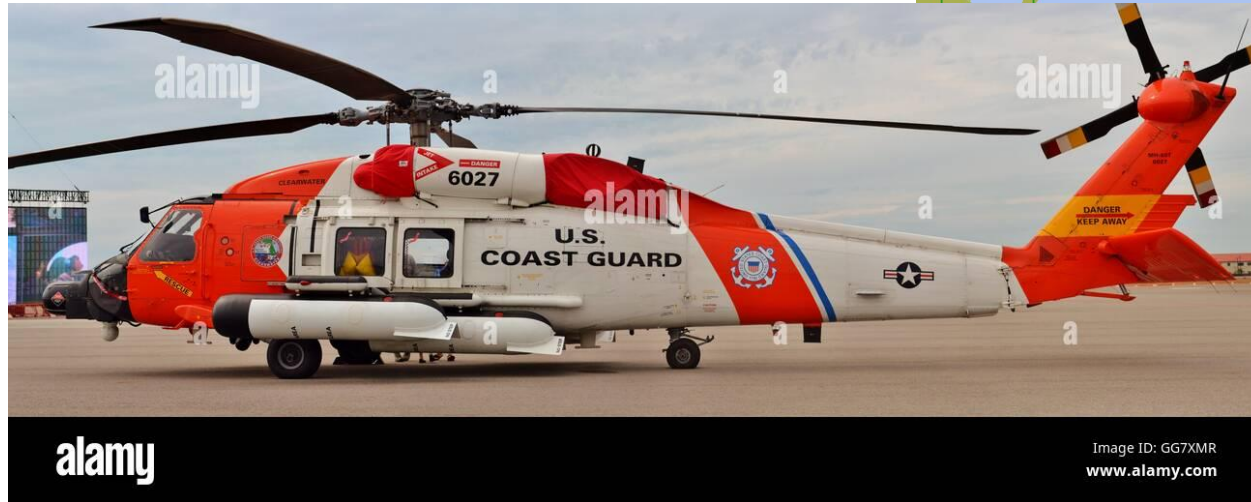
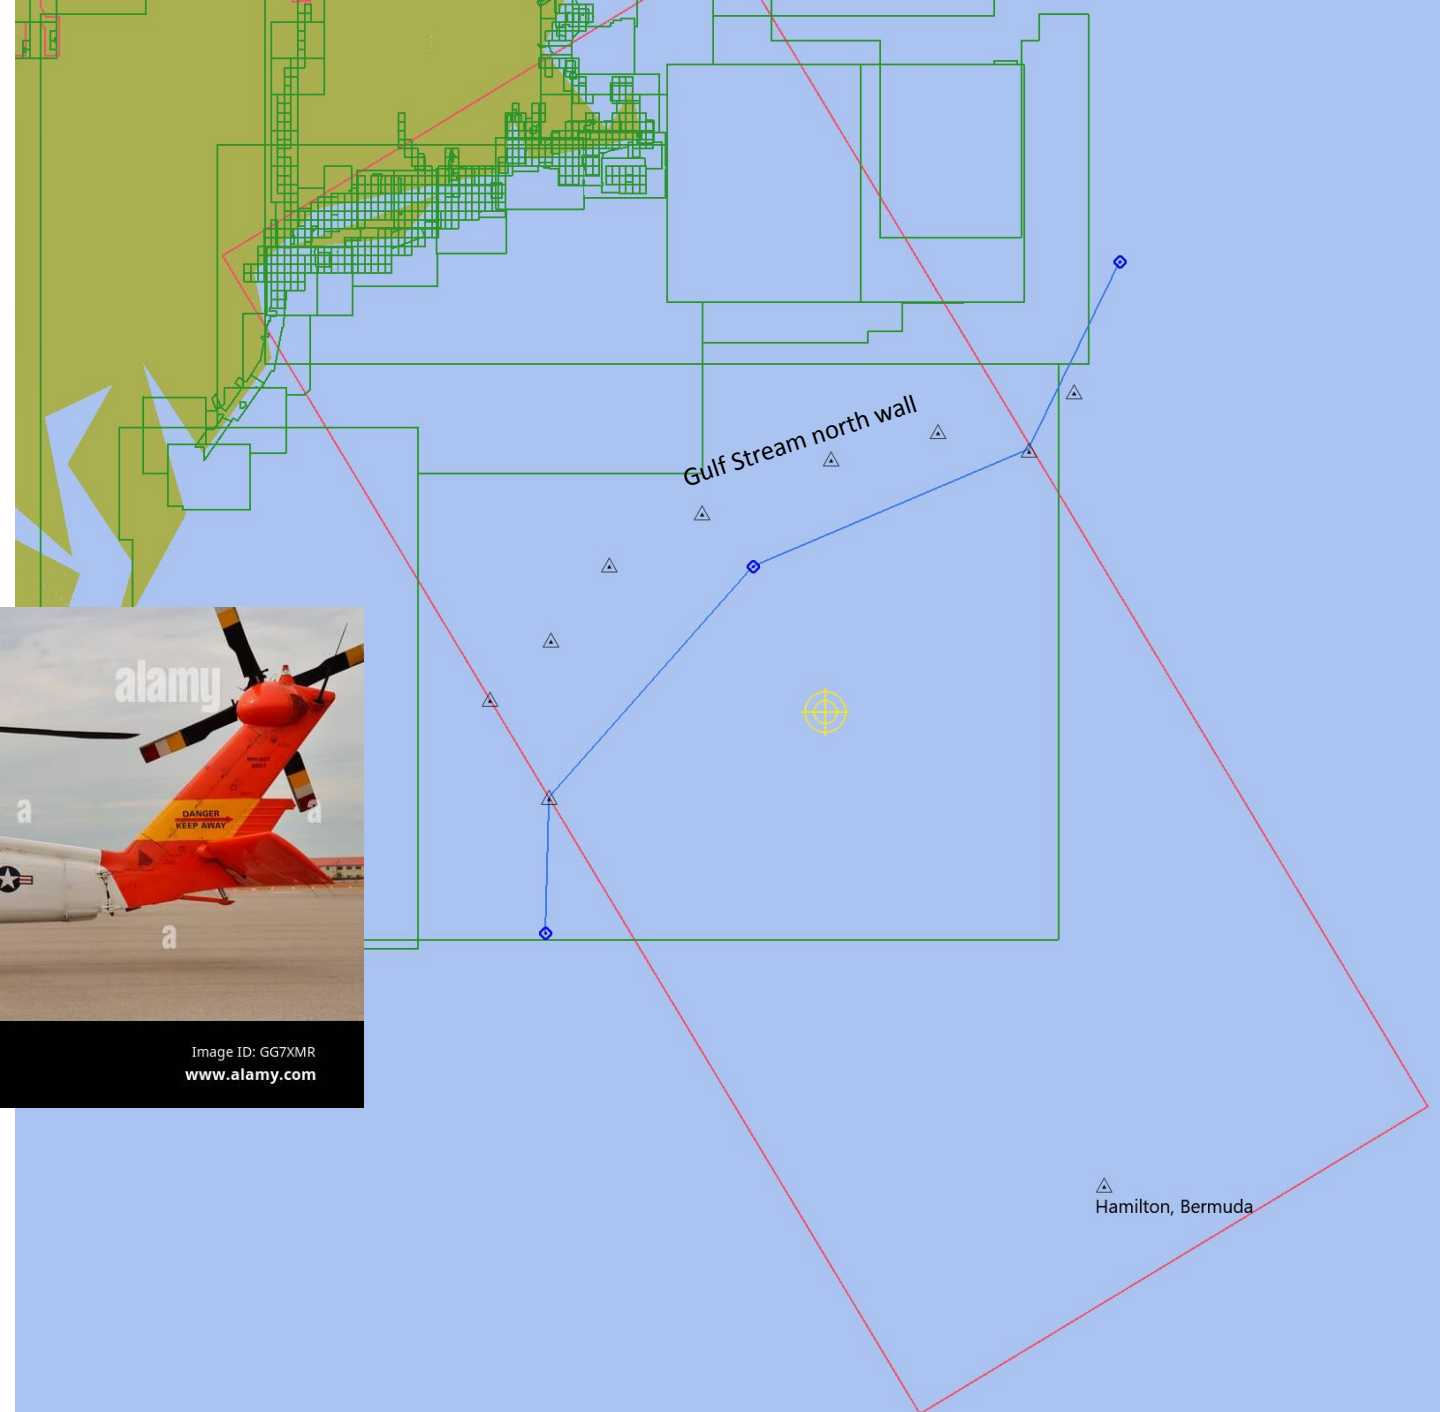
Crew had unrealistic expectations for a USCG on scene response. Morgan of Marietta was outside helicopter range and the victim was already dead. USCG did not dispatch any assets.

Blue line is the 300 NM operational range of USCG MH-60 helicopters from air stations at Cape Cod and Atlantic City, New Jersey. There are no rescue helicopters in Bermuda.
