## **REPORT ON THE SINKINGS OF THE SAILING VESSELS *GUNGA DIN* AND *ALLIANCE* DURING THE 2024 NEWPORT-BERMUDA RACE**

Conducted by: James D. Phyfe, III, David Pedrick – President, Pedrick Yacht Design, Harry Dunning – Dunning and Associates, LLC, and J. Michael Keyworth

Issued: 4 May, 2025

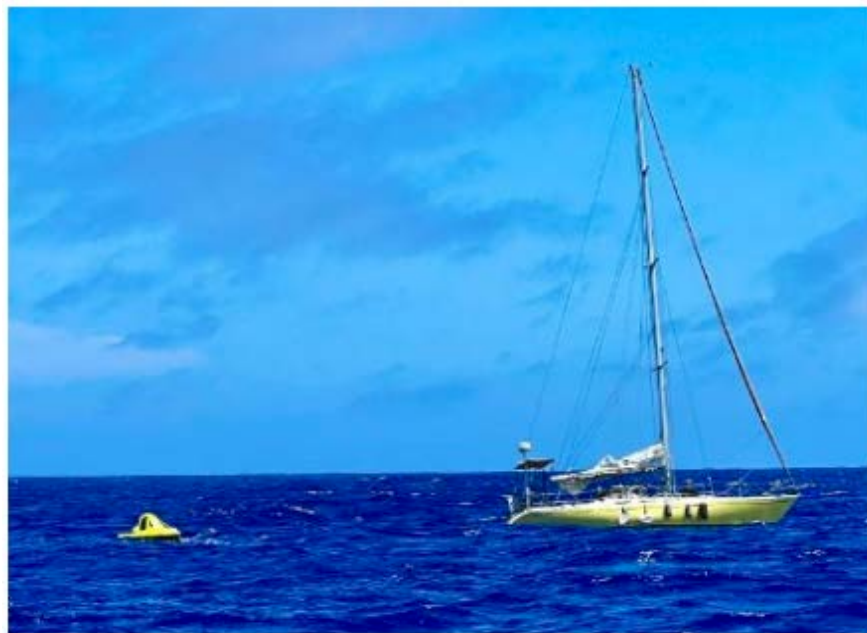
**FIGURE 1** – Photo of *Gunga Din* taken during the abandonment. The headstay is noticeably slack.

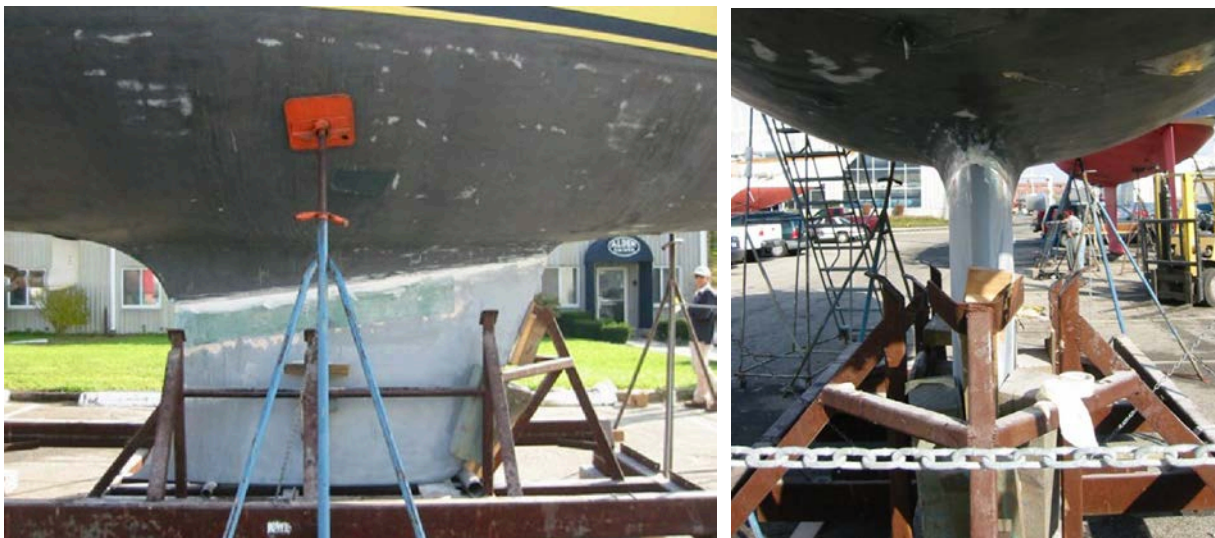
**FIGURE 4** – Note the tight fit of the replacement keel to the existing keel stub.

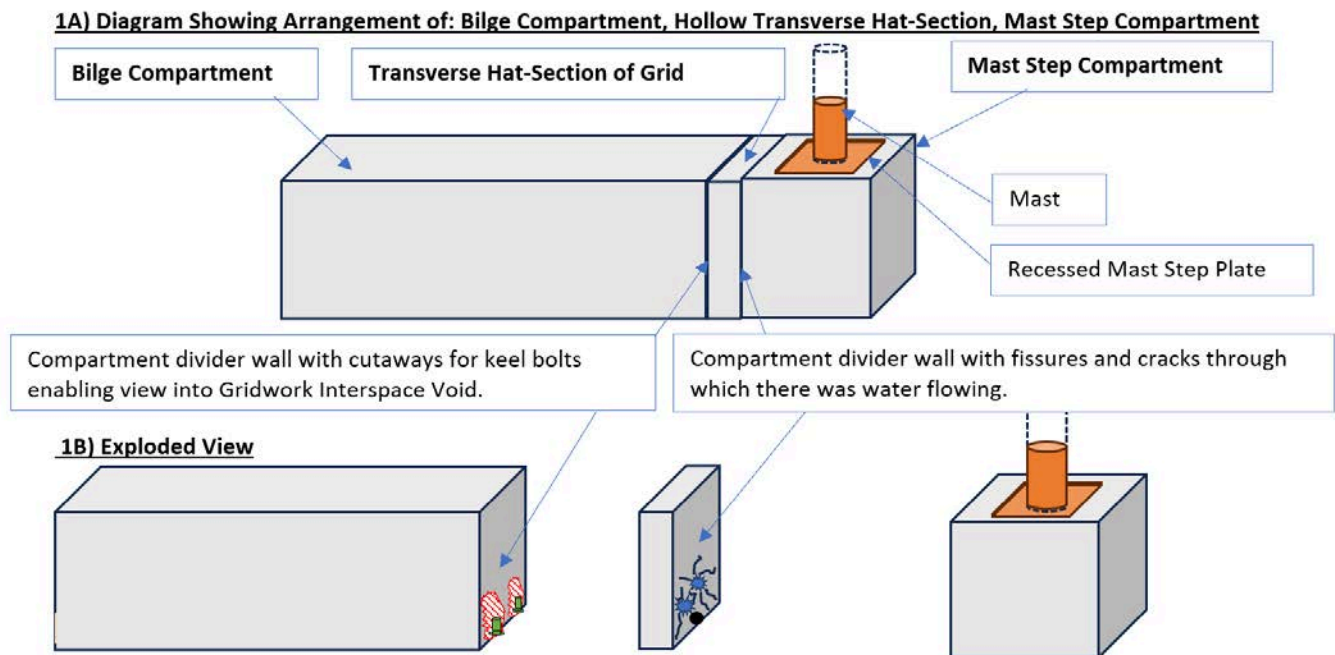
**FIGURE 6** – Dr. Alec Fye’s diagrams of the damage he observed.

Referring to Figure 6 and per Alec Fye’s notes at the top, the set of boxes portrayed in 1A represents the space under the cabin sole (floorboards) that required removal of the salon table for access. The bow is to the right in this diagram. Although the spaces are drawn with enclosed sides, what’s inside each box warrants explanation. The large, left box is the open-topped bilge bay between the inboard walls of the grid’s longitudinals. The bilge bay’s forward face is the same as the aft face of the next thin slice. The thin box represents the hollow transverse “hat-section” located at the after end of the mast step. This was part of the structural grid. The forward box represents the mast step compartment. The orange post and plate represent the mast and recessed heel plate.

The exploded view adds sketches of damage in both faces of the hollow “hat section.” However, the damage was seen from aft. Details of damage have been sketched on their respective forward faces in Figure 6. The next two sketches (figures 7 and 8) show how these two faces appeared to Alec Fye when viewed from aft.

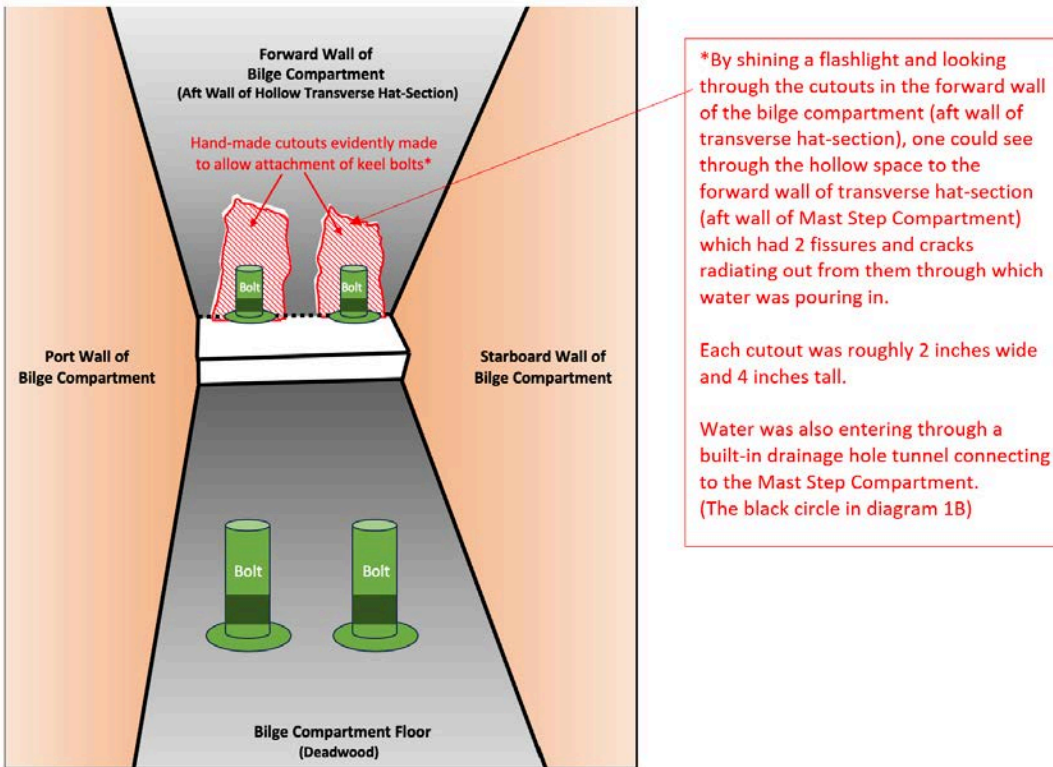
At this point, it is important to take note of modifications to the hull grid made by an unknown party at an unknown date. When Alec Fye looked forward from the open topped bilge bay (left box), he observed two jagged, crudely-cut holes in the aft face of the “hat-section” separating the open bilge bay from the mast step compartment. These holes, which may have been cut with a reciprocating saw around the time of the keel replacement, appear to have been made for the purpose of accessing the forwardmost pair of keel bolts. Alec Fye describes them each being approximately the size of a deck of cards. It was through these two holes that he could see the water streaming through a “spiderweb” of cracks in the forward face of the “hat-section.”

It is a little unclear how these holes came to be, but it is possible that, although the new keel was designed to fit the existing bolt pattern, the forwardmost pair of bolts on the new keel were slightly forward of the old ones. Hence, the need to gain better access. It is equally possible they were made at some other time. Either way, these two jagged, irregular cutouts in a key structural member supporting the mast step most likely weakened it significantly – certainly compromising the designed strength and purpose of this key part of the structure.

FIGURE 7 – Dr. Alec Fye’s diagrams of the damage he observed.

3) View Looking Forward Through One of the Cutaways into Gridwork Interspace Void to see Aftmost Wall of the Mast Step Compartment which had Two Fissures & Cracks Radiating Outward Through which Water was Entering

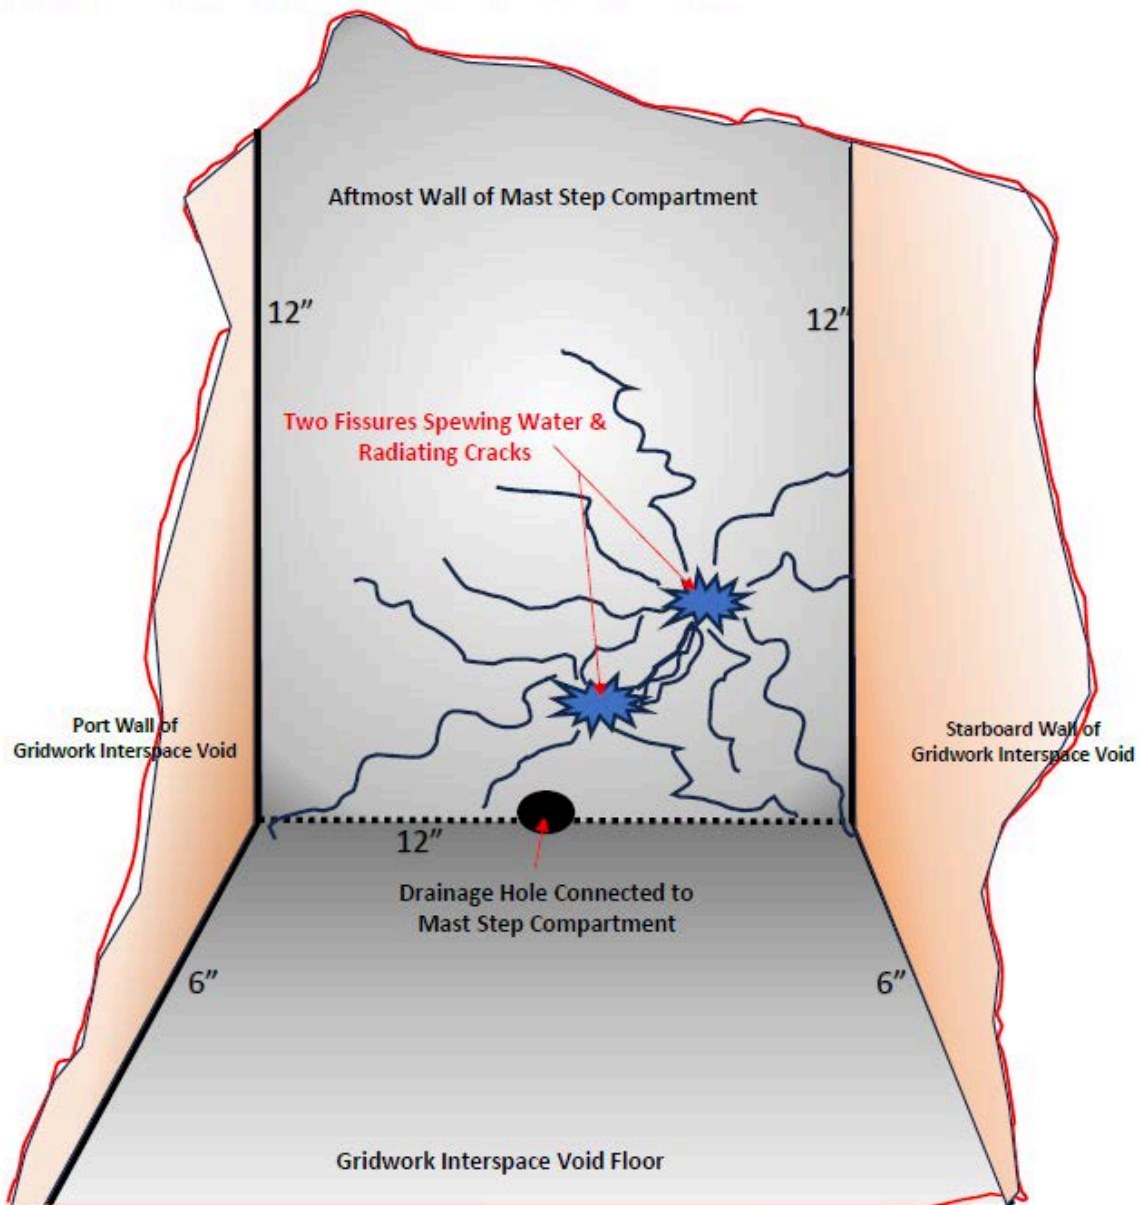
**FIGURE 8** – Dr. Alec Fye’s diagrams of the cracks he observed through which water was flowing. Note that water was also seen running aft through the pictured limber hole.

How did this spiderweb of cracks in the forward face of the “hat section” develop and what were its implications? As noted, this transverse member of the hull grid was directly aft of

the mast step and in the area of the forwardmost pair of keel bolts. Although it cannot be said with certainty, the conditions leading to the formation of these cracks most likely have roots to the decision to cut crude access holes to better access the forwardmost pair of bolts.

The structural consequence of this is such that the nuts and washers on the forward keel bolts put very high downward stress into the immediate fiberglass hull. This can result in delamination fractures within the thickness of the fiberglass shell at the keel bolt holes, compression of the fiberglass and cracking in the resin. Additionally, the already weakened structure of the mast floor web provided diminished resistance to athwartships bending in the bottom of the keel stub from the surge in keel bolt tension. This causes permanent damage. Therefore, the combined effects of the modified hull framing grid structure exacerbated by the impact of two known groundings most likely weakened the area beneath the mast step to a degree that three days of heavy upwind pounding into steep, confused seas caused the mast to "jackhammer" its way into the weakened structure, ultimately causing catastrophic flooding. This process was apparent in hindsight in the gradual but visible loosening of the headstay, inner forestay and backstays that the crew observed, which indicated that the mast was being pushed down into the hull relative to the hull's chainplate foundations.

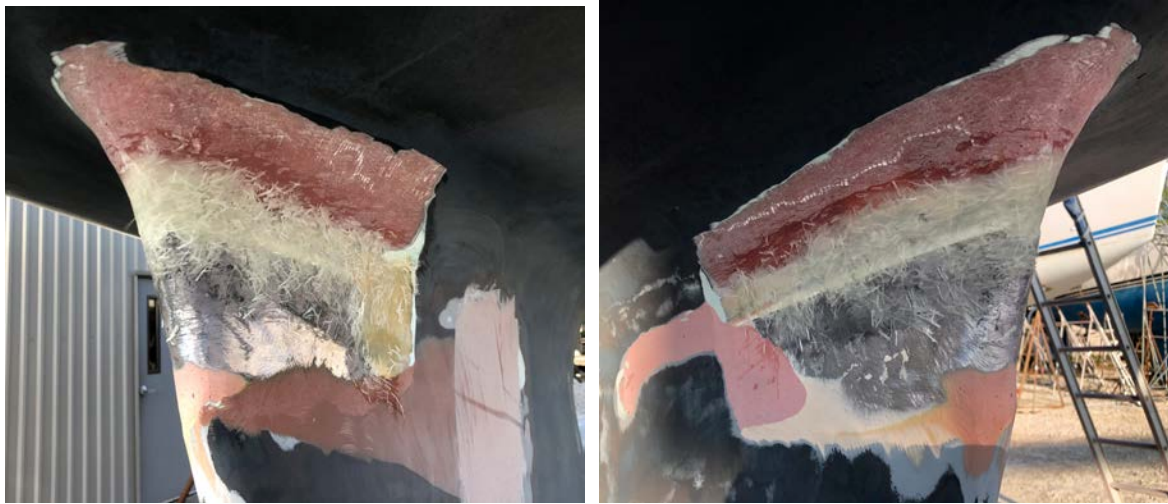
We do know from interviews with the owner and Jamestown Boat Yard that *Gunga Din* was pulled from the water in November of 2023 for inspection and repairs. Photo evidence

(Figure 9) shows us that the yard performed some repairs to the intersection between the hull and keel, but those repairs do not appear to have extended into the hull itself. Therefore, it appears that while the intention and desire to investigate and repair the area prior to the 2024 Bermuda Race was there, the adjacent hull was not examined as part of the process. The easily accessible keel boats were also reportedly retorqued, but not the inaccessible ones.

**FIGURE 9** – Photos of repairs to the hull – keel interface taken during November, 2023 repairs to the keel.

3. It is highly recommended that after a hard grounding a vessel be inspected by a qualified party who will grind back the gelcoat, take core samples and/or conduct ultrasound imagery. Visual inspection after such incidents is not adequate to unmask the potential scope of damage.

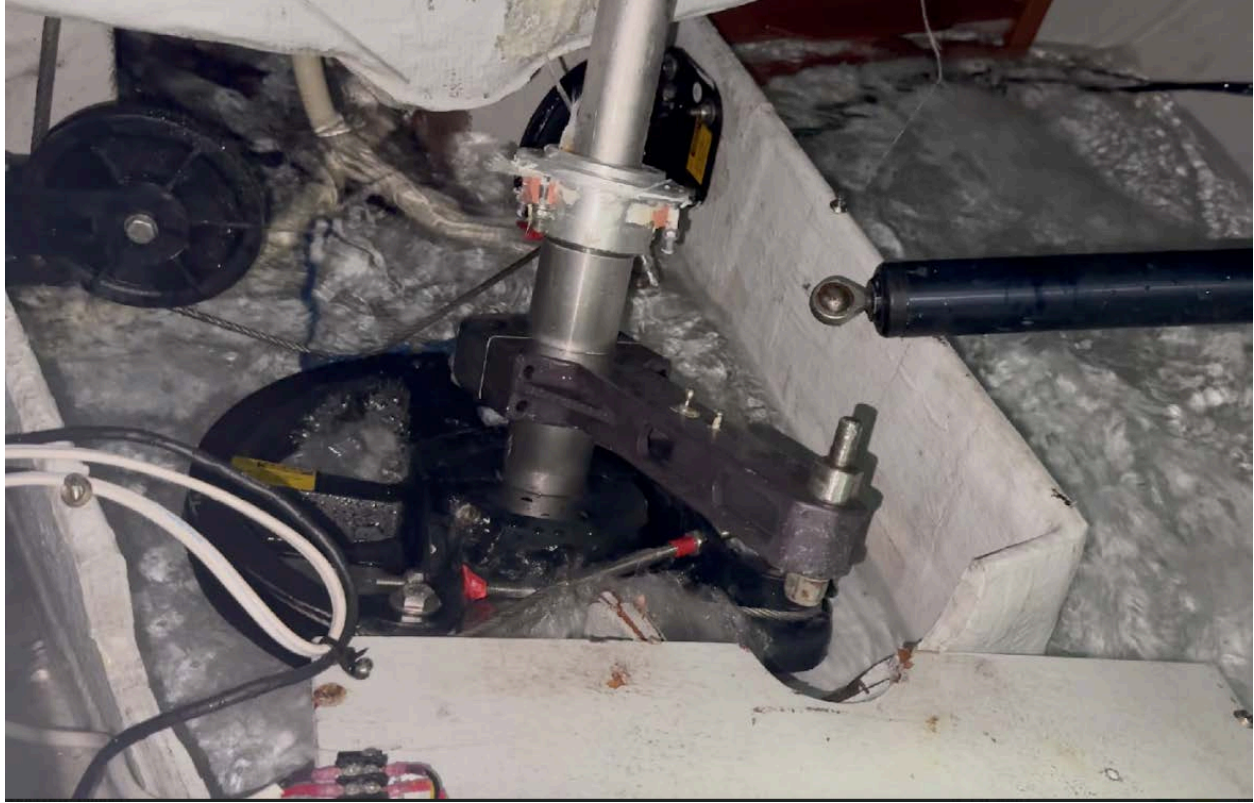
**Figure 1** This picture, taken approximately 40 minutes after the incident, shows the damage and flooding to Alliance. The upper rudder bearing is visible mid-picture above the autopilot tiller arm, having slid down the rudder stock from its original position in the cockpit sole.

It is known that the incident caused the upper rudder bearing to tear away from the cockpit sole where it was mounted and slide down the rudder shaft. At about the same time, movement of the rudder stock rotated the lower bearing housing and opened up a hole in the hull just ahead of it.

Figure 1 above shows that the upper bearing was intact when it slid down the rudder shaft and the mounting bolts remained in place. There is evidence of fiberglass and compound still attached to the mounting bolts, which could explain the burning smell Irwin and others noted immediately after the incident. It is likely the force required to unseat the bearing and the violence with which it became dislodged created tremendous heat in the surrounding structure, causing the “fiberglass burning” odor.

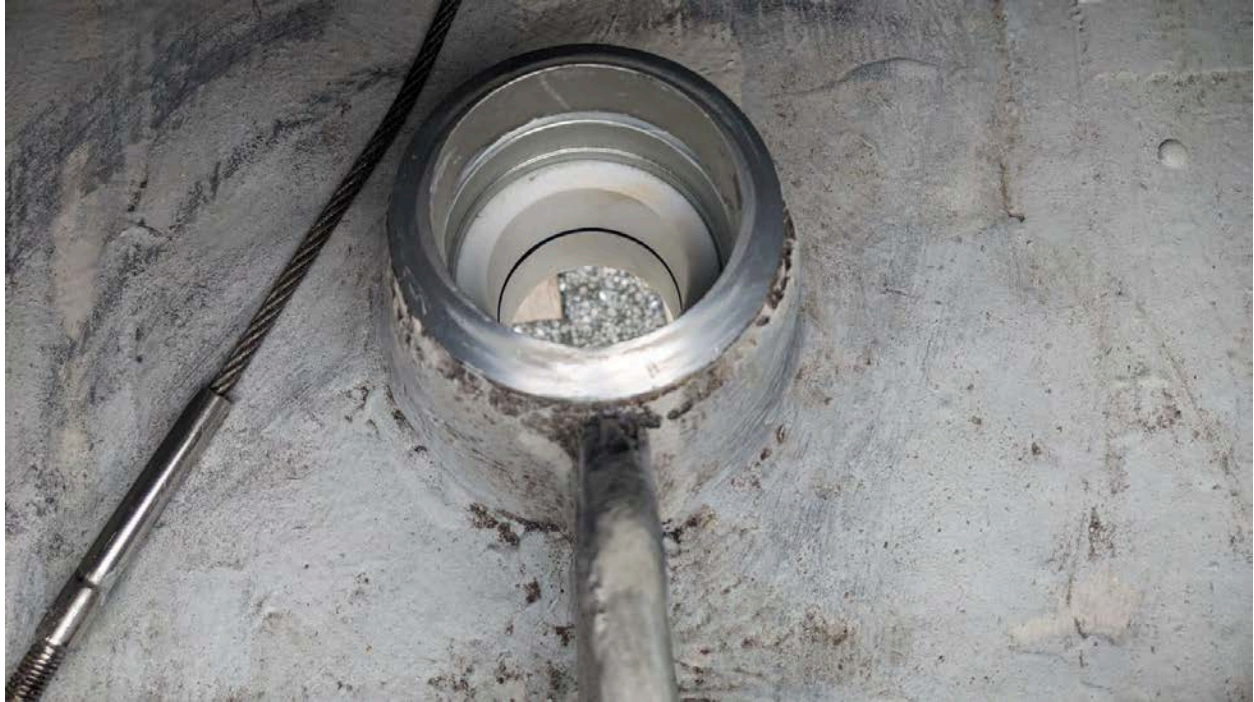
The lower rudder bearing was a self-aligning JP3 bearing manufactured in France. As previously mentioned, it had been replaced by a boat yard during the winter of 2023-4. Interviews with the technician who conducted the replacement did not indicate anything out of the ordinary was discovered during the process.

**Figure 3** A photograph of the lower bearing on *Alliance* and its fiberglass and aluminum housing. This picture is taken from aft looking forward. Note the longitudinal support immediately aft of the structure.

3. Rudder bearings require maintenance. Detailed instructions can be obtained from the bearing manufacturer, but it is recommended that the rudder be dropped so the bearings and surrounding structure can be inspected and cleaned at least every three years. Any difficulty or change in steering performance should be investigated immediately.

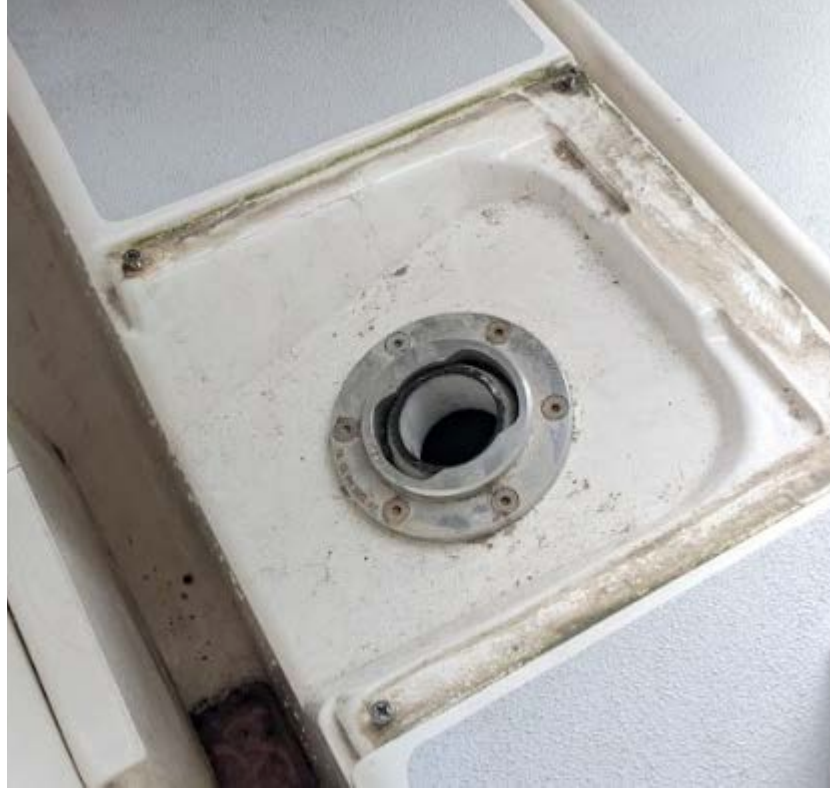
**Figure 4** The upper rudder bearing aboard *Alliance* when viewed from on deck. Note that the bearing is located immediately aft of the wheel well (visible) in the cockpit sole and is normally covered by a removable fiberglass plate.

As previously discussed, the upper rudder bearing on *Alliance* was flush mounted in a composite panel and secured by six through-bolted fasteners (“mounting bolts”). The opening in which the bearing was mounted was slightly larger than the outside diameter of the external vertical face of the bearing, such that when the fasteners were removed to re-bed the bearing in the spring of 2024, the bearing could be moved fore and aft and athwartships by “about 4 to 5 mm” according to Kneller. We have found that this is a common practice among vessels of similar vintage across a number of manufacturers. The result is that the horizontal forces exerted on the bearing are supported solely by bedding compound (if any) and the mounting bolts and not the deck structure surrounding it.

According to representatives of PYI, the US distributor for JEFA rudder bearings, the upper bearing mounting bolts are not designed or engineered to support the significant horizontal loads imposed by the forces of a deep rudder maneuvering in a large seaway.

Therefore, PYI recommends that the bearings be tightly fitted within the supporting structure such that the loads may be spread across a greater framework of support. Because the mounting bolts are not designed to support the lateral loads, they may loosen or fail altogether, leading to a loss of rudder support at the upper bearing.

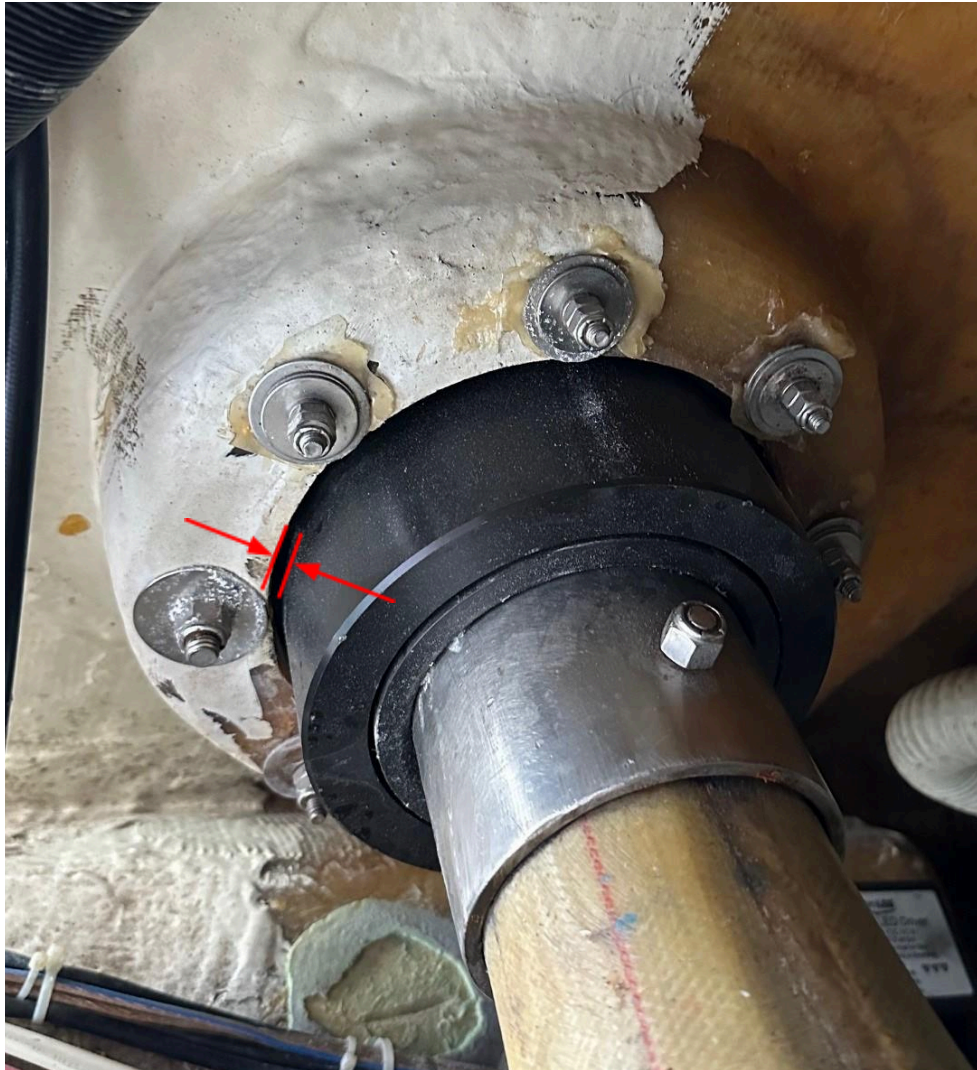
**Figure 5** A loose-fitted upper rudder bearing (vessel type not specified). Note the gap between the external face of the bearing and the structure in which it is mounted. In this case, all lateral loads are dependent on the through-bolted fasteners.

1. With advances in technology and design, critical components are facing increased point loads in normal sailing conditions. Design evolution to open-transom boats lowers the upper rudder bearing to the cockpit sole, necessarily creating significantly higher stresses on it due to the shortened lever-arm. As a result, proper structural engineering and bearing installation are paramount. Rudder bearings ought to be installed in strict compliance with manufacturer specifications. Upper bearings should be mounted in such a way that the significant forces on them are spread appropriately through sufficient surrounding deck or hull structure. This includes a tight fit between the bearing and the structure it is mounted in.

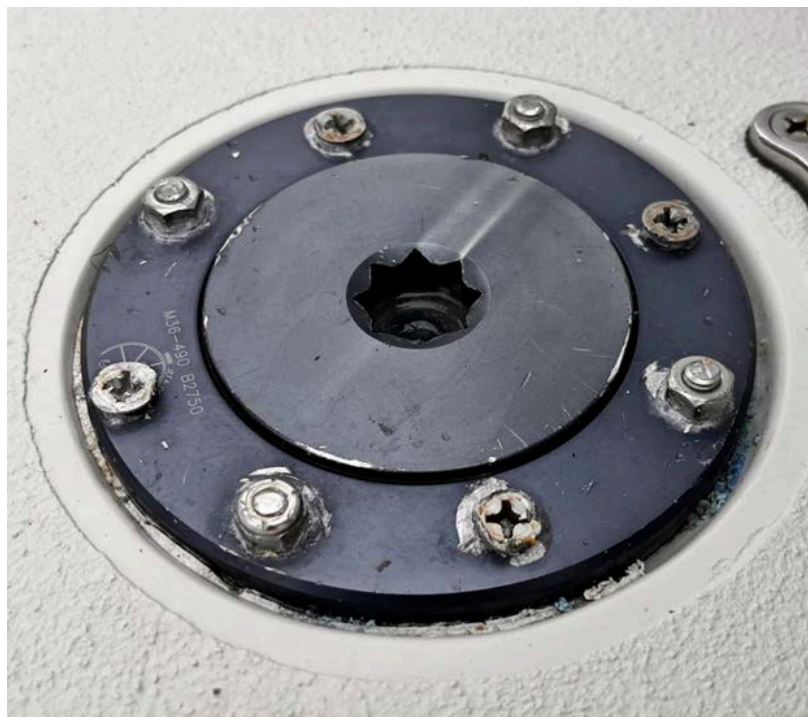
that, similar to *Alliance*, the top bearing of *Ceilidh* is mounted in the cockpit sole aft of the helm). The top bearing on *Ceilidh* was secured by four throughbolts with lock washers on the underside. When a crewmember went to tighten the throughbolts, he found two of the four had sheared completely at their heads. The crew located two similar bolts in the ship's spares, but less than an hour after replacing them, they noticed the flange moving again. Fearing the remaining bolts would also shear, the crew drilled four additional holes in the flange and into the solid fiberglass panel below it, which they used to add an additional four large self-tapping screws. This arrested any further movement of the flange and held until they arrived in Bermuda.

**Figure 9** The repaired bearing aboard *Ceilidh*.
