## **REPORT ON THE SINKINGS OF THE SAILING VESSELS *GUNGA DIN* AND *ALLIANCE* DURING THE 2024 NEWPORT-BERMUDA RACE**

Conducted by: James D. Phyfe, III, David Pedrick – President, Pedrick Yacht Design, Harry Dunning – Dunning and Associates, LLC, and J. Michael Keyworth

Issued: 4 May, 2025

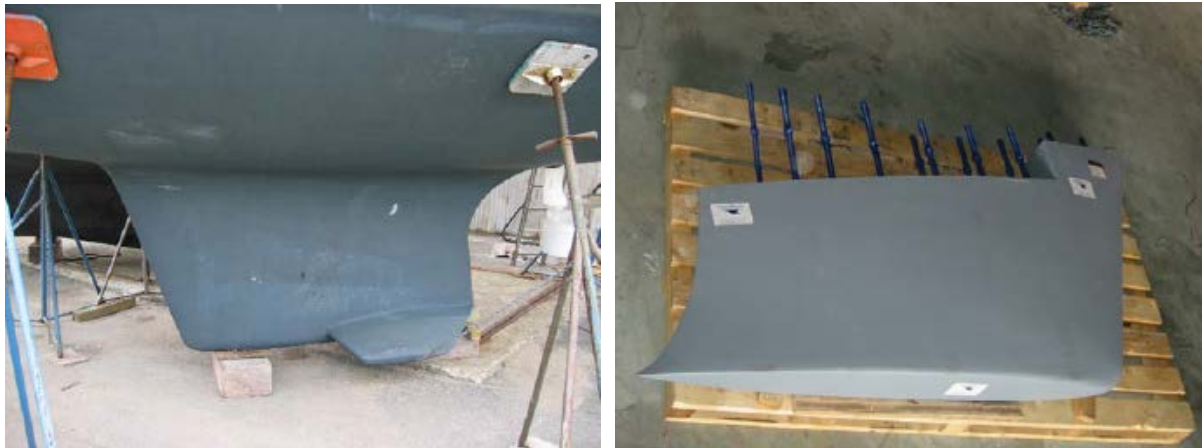
**FIGURE 2** – Original and 2005 replacement keel.

According to Pedrick, the project had time and budget constraints, and thus the new keel would utilize the existing footprint and keel bolt layout. The new keel would be 12-inches deeper and would not contain appendages (“wings”). The new keel would, however, increase the righting moment by approximately ten percent in addition to providing improved upwind performance associated with deeper draft. Pedrick considered the existing structure adequate to support the additional righting moment. The keel replacement was completed in the Spring of 2005 (see Figure 2 below).

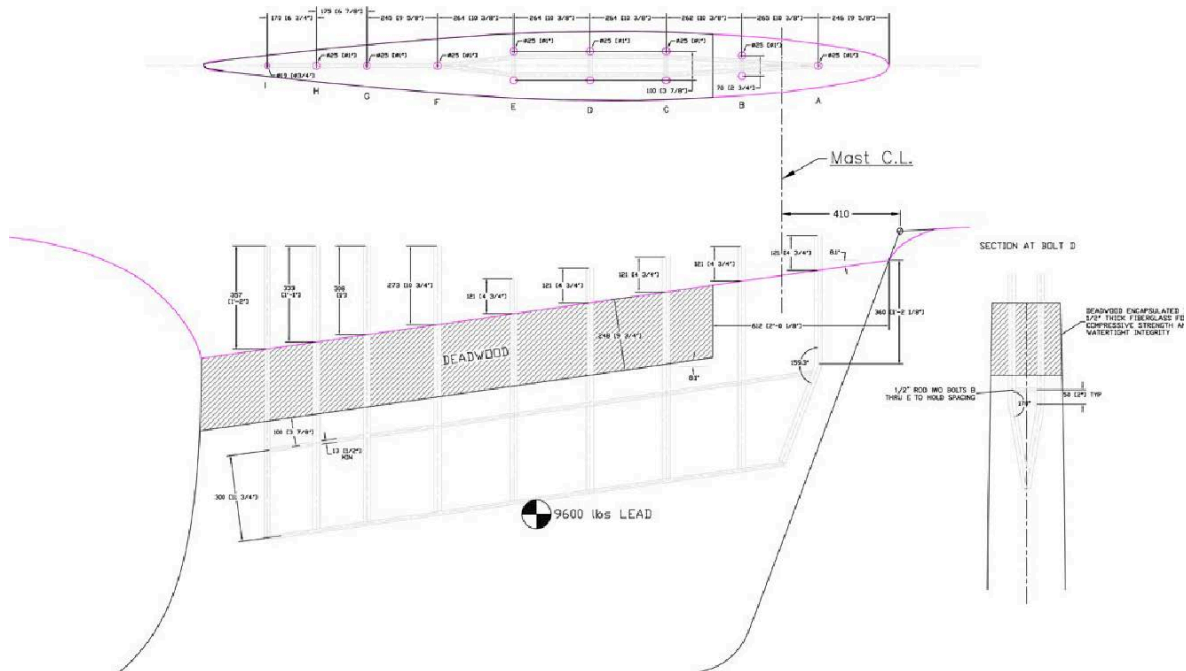
**FIGURE 3** – Design drawings of the 2005 replacement keel on *Gunga Din*

In order to maintain consistent vertical and longitudinal centers of gravity, the new keel contained an area of “deadwood” for most of the aft 2/3rds, while the forwardmost part was bolted directly to the hull for strength (Figure 3). On installation, the replacement keel fit the existing keel stub quite closely (Figure 4).

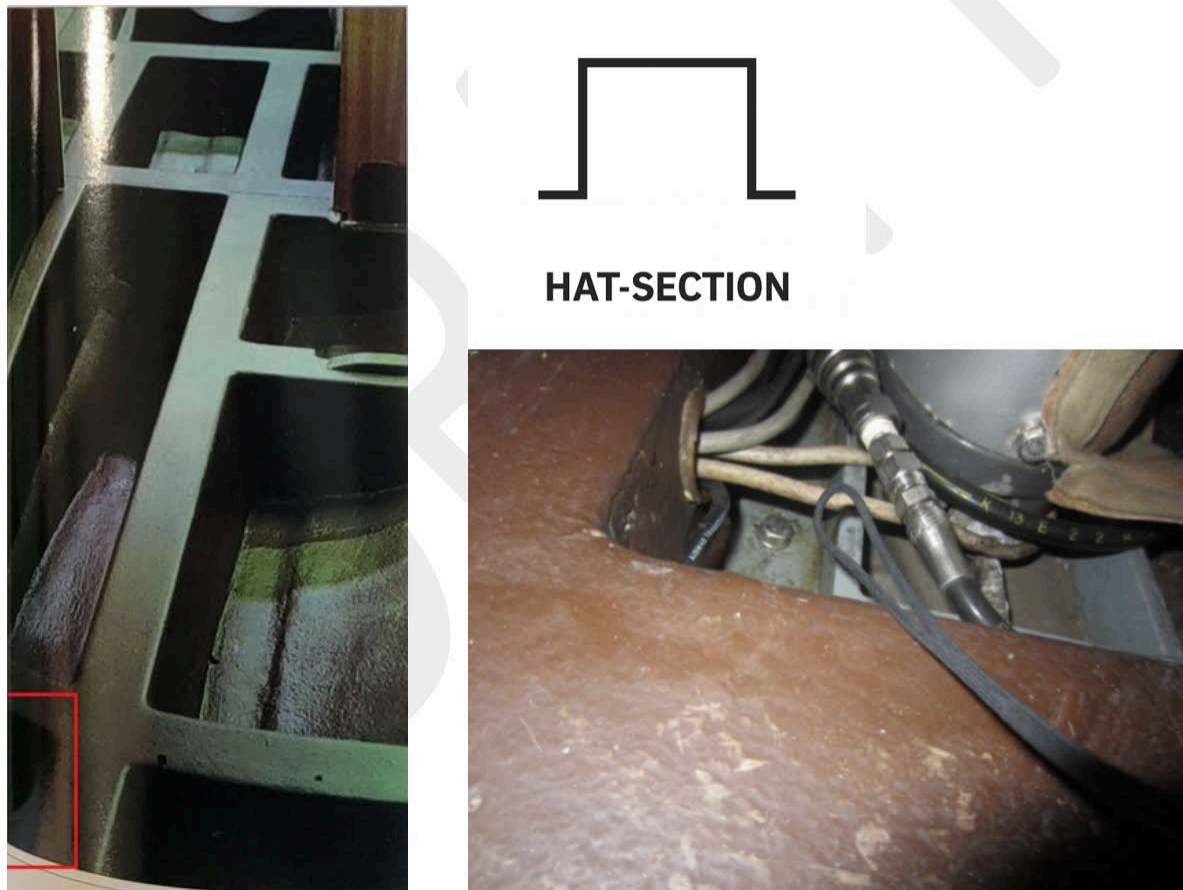
When Alec Fye located the water entering the vessel from underneath the mast step, he noted that the water appeared to be coming through a spiderweb of cracks in the bottom framing grid of the hull. As printed in Ferenc Mate’s *The World’s Best Sailboats* (1986), Sweden Yachts had adopted an integrated, molded hull bottom framing grid (Figure 5), an innovation at that time introduced by Pedrick Yacht Designs in 1979 after a request from Ericson Yachts for a more robust method to provide structural stability across the hull. According to Pedrick, this arrangement is “a molded grid of hollow, integral transverse and

**FIGURE 5** – Photo from Ferenc Mate's **The World's Best Sailboats** featuring the Sweden 41 with its innovative molded hull bottom framing grid. This photo shows a Sweden 41 under construction and shows the grid and keel root from forward looking aft. The red box indicates the location of the recess in which the mast step would later be installed. To the right is a depiction of a "hat section" and a photo of *Gunga Din's* mast step recessed in the cavity.

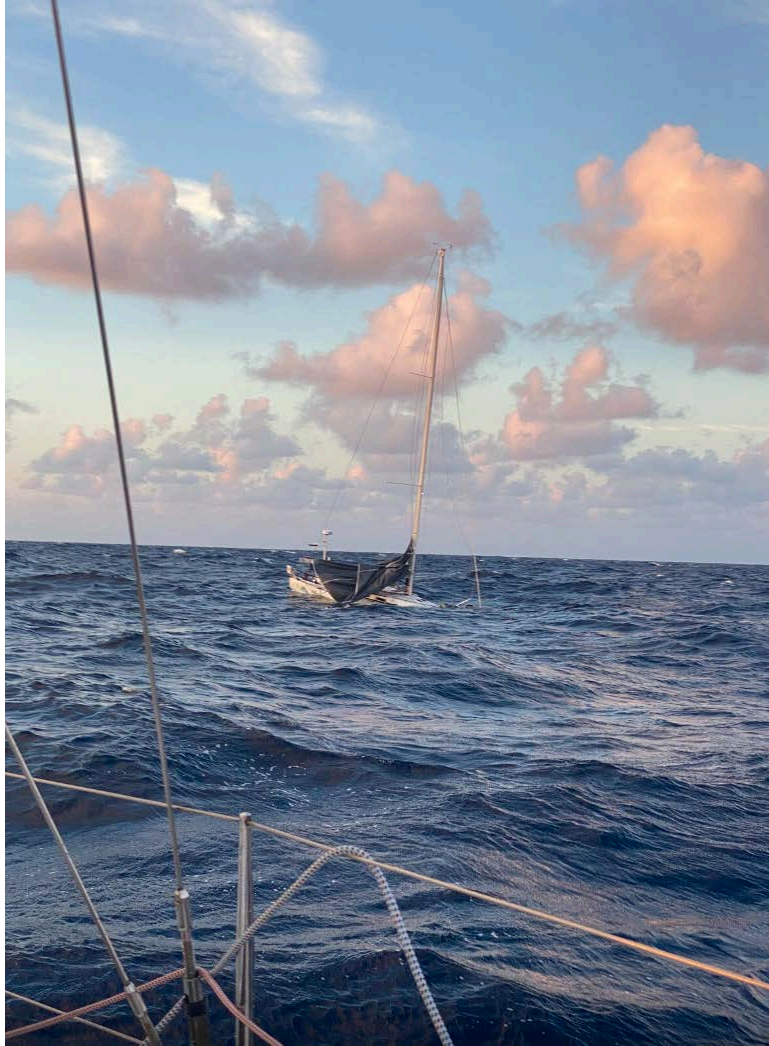
**Figure 2** The last known photograph of Alliance taken by a passing competitor shortly after dawn June 23<sup>rd</sup>.

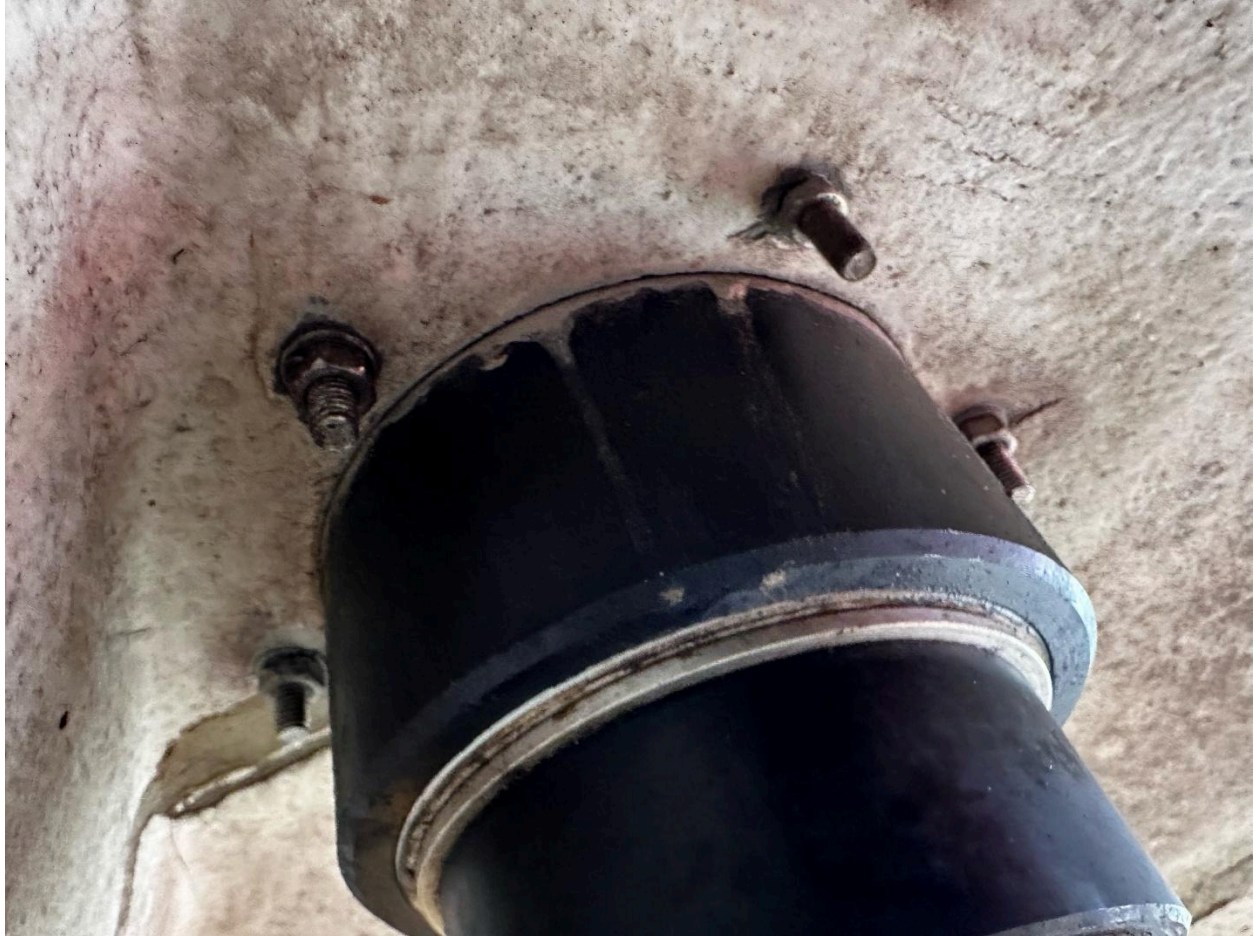
**Figure 6** Photo supplied by PYI, Inc., of a properly fitted upper rudder bearing (vessel type not specified). Note the tight tolerance between the outside of the bearing and the surrounding deck structure.
